# FIRE RESISTANCE TEST REPORT

**DOUBLE-LEAF COMPOSITE TIMBER DOOR with METAL CLADDING, A GLAZED ELEMENT AND A GLAZED SIDE PANEL**

in accordance with **BS EN 1634-1: 2008**

Report Number: IT16-132

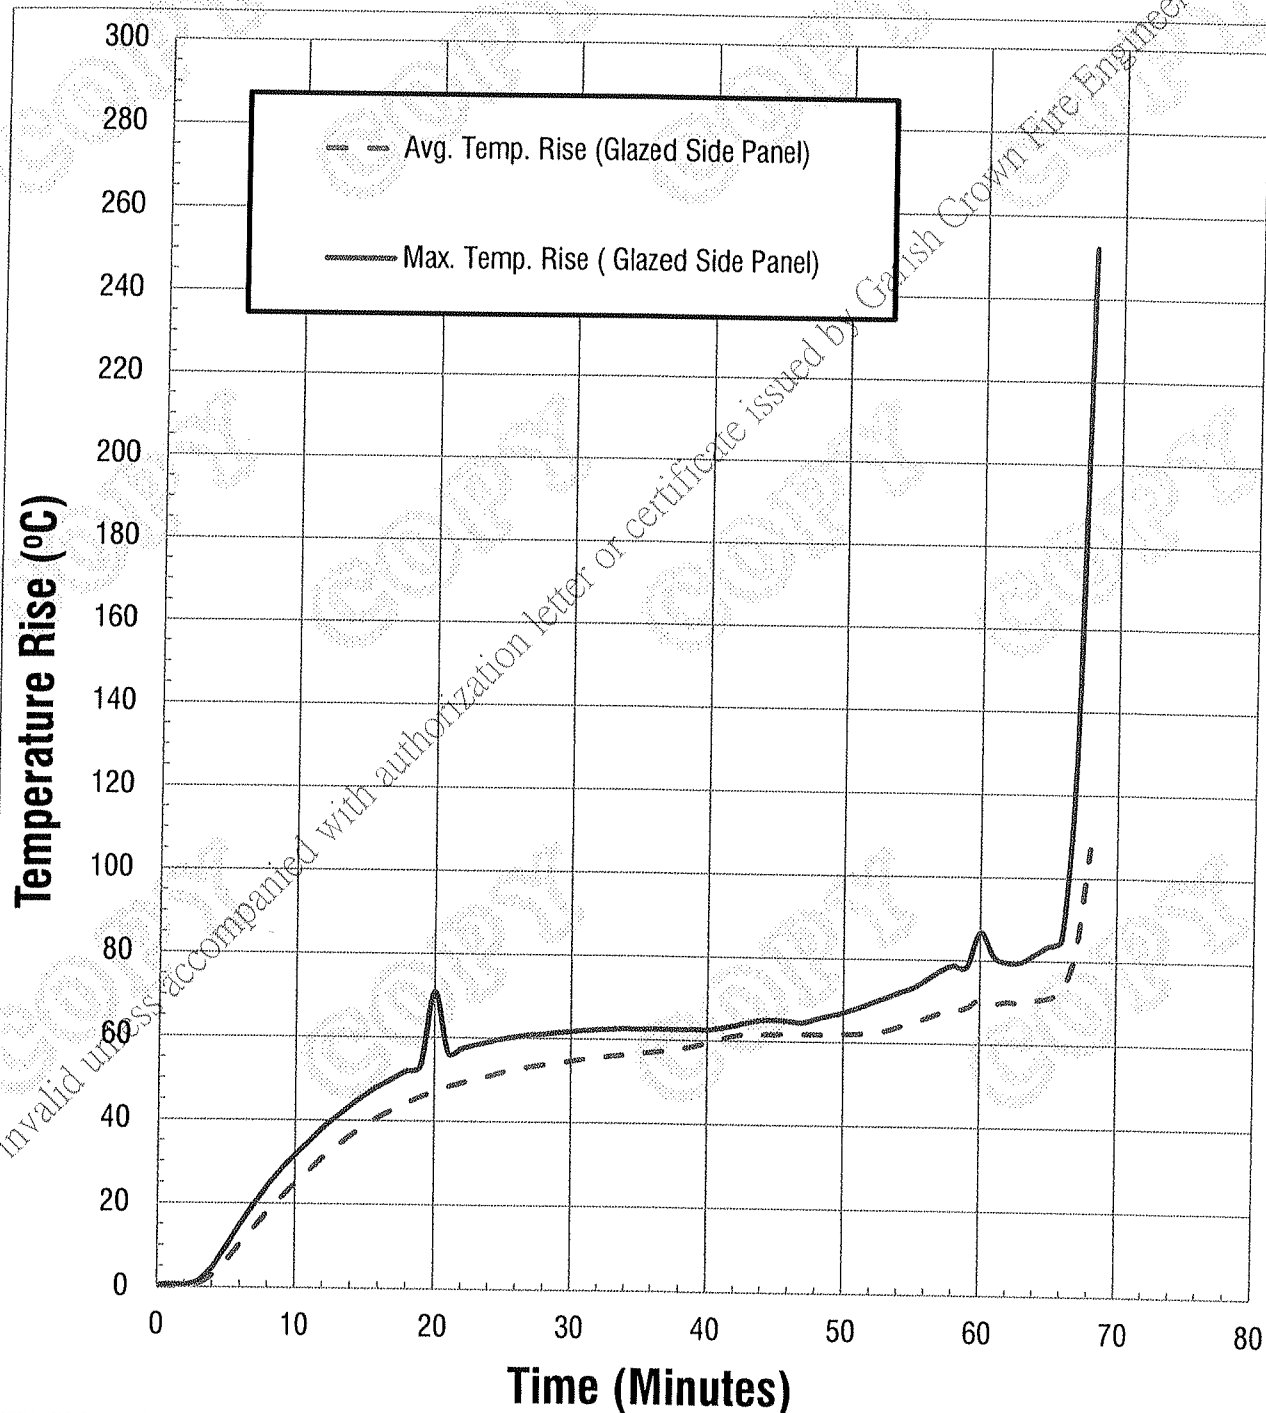
**Figure 8.** Average and maximum temperature rise on fixed glazed side panel over the test period.

The maximum temperature rise of glazed side panel at 67.5 minute of test at U26 was 182.0°C which was in excess of 180°C limit.

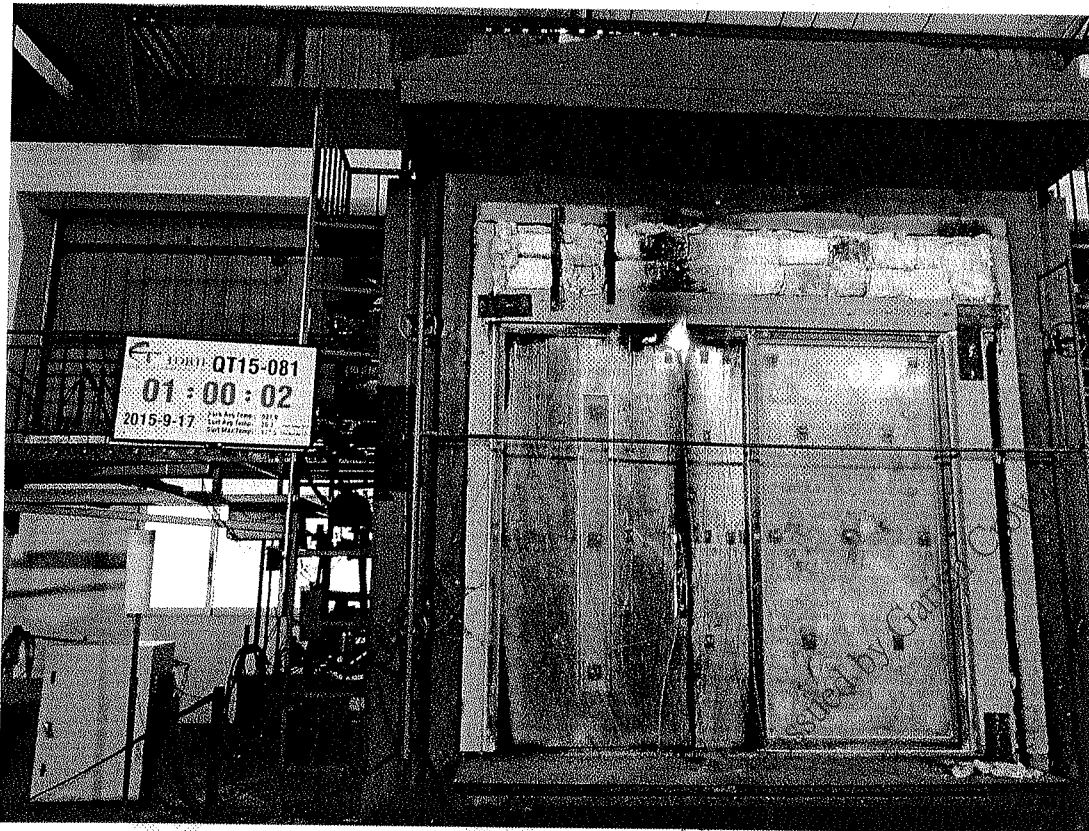
57.39	Sustain flaming appeared at the top of meeting edges. <b>INTEGRITY FAILURE OCCURRED.</b>
57.41	Cotton fibre pad test was carried out at the top of meeting edges. Flaming on the cotton pad was observed.

**Photo 5.** Unexposed surface of the specimen at 60 minute of test.

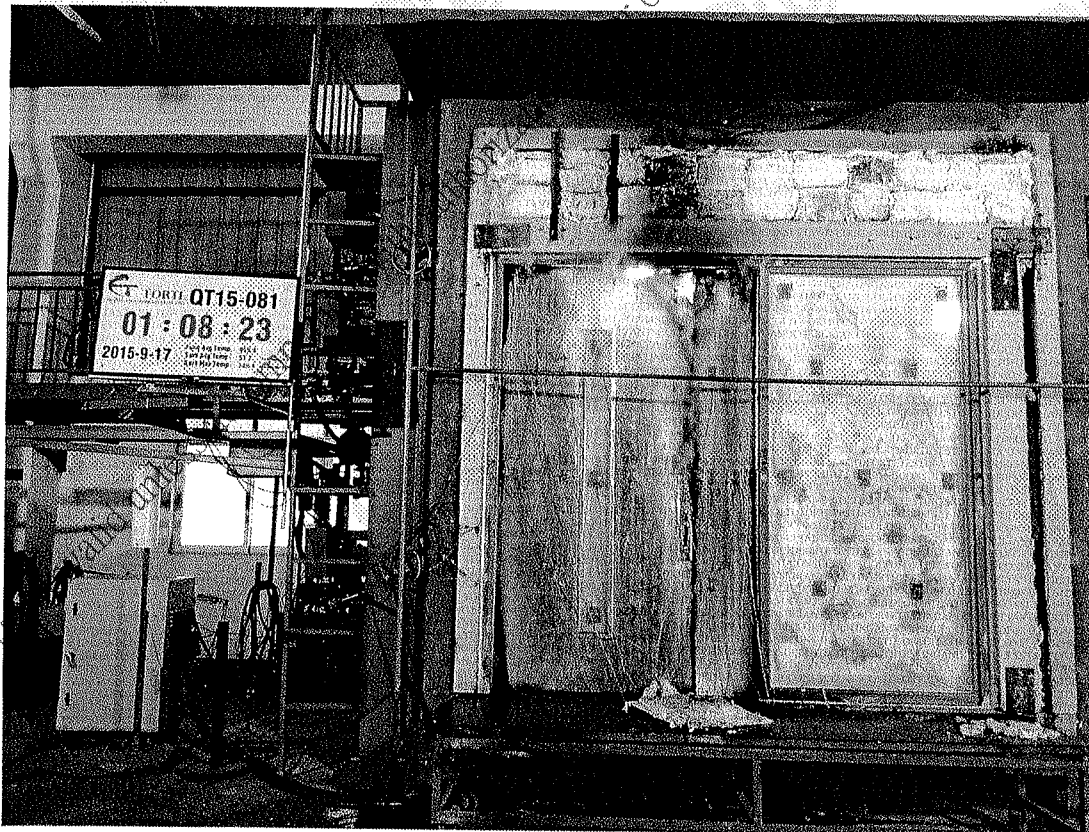
**Photo 6.** Unexposed surface of the specimen at the end of test.
