This report was a record of a fire resistance test conducted by Forte Testing and Consultants Co., Ltd, in conformity with requirements in *BS EN 1634-1: 2008 "Fire resistance and smoke control tests for door, shutter and openable window assemblies and elements of building hardware Part 1: Fire resistance tests for doors, shutters and openable windows"* and particular requirements in *BS EN 1363-1: 1999 "Fire resistance tests – Part 1: General requirements"*.

The test subject was single-acting single-leaf composite timber sliding door with two air transfer grilles namely Door A, louver systems, namely louver B and louver C. The specimens were supplied for test by Garish Crown Fire Engineering & Consultancy, the Sponsor.

REPORT no.: IT19-129

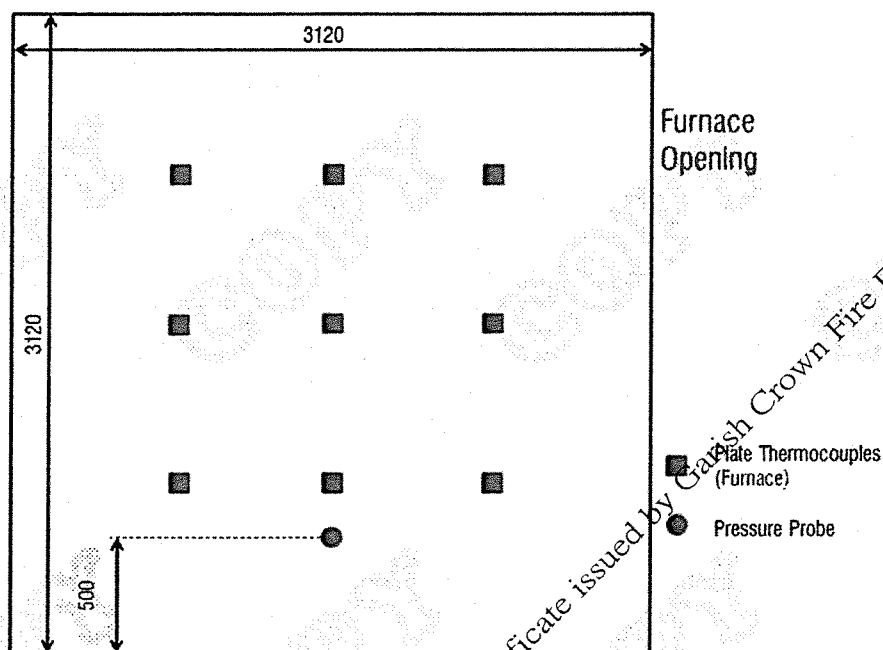
The temperature inside the furnace was measured in conformity with *BS EN 1363-1: 1999* by 9 numbers of plate thermometers. These thermometers were evenly distributed over a vertical plane approximately 100 mm from the exposed surface of the test construction.

Figure 1. Position of thermocouples and pressure measuring probe inside the furnace.

The positions of furnace thermocouples were shown in *Figure 1*.

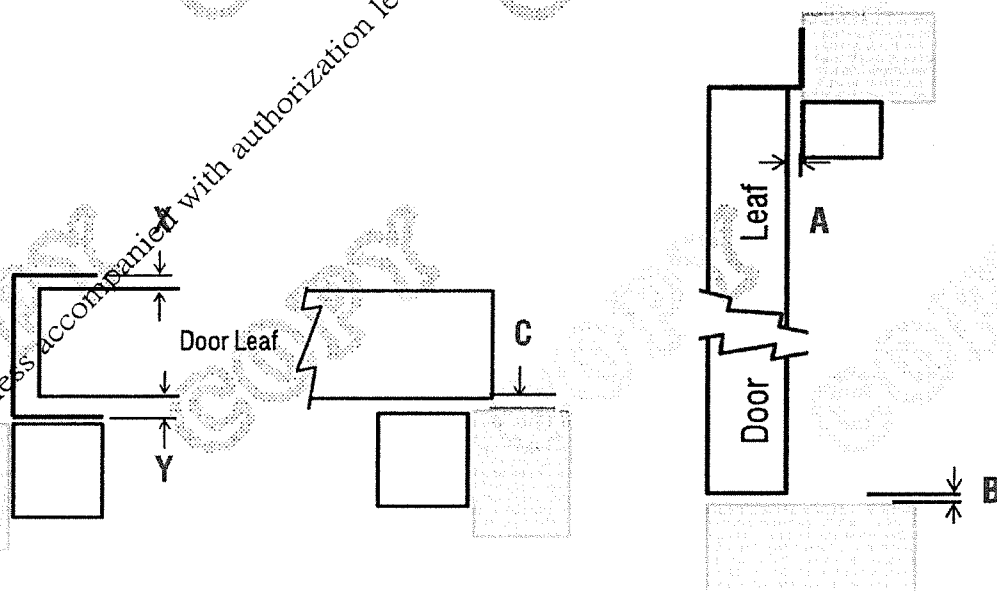
The widths of frame-to-leaf or leaf-to-leaf gaps were measured after the door assembly and prior to the test. Measurement positions were shown in *Figure 2*.

Figure 2. Primary gaps measurement positions on Door A.

Gap	Measured		
	Minimum	Maximum	Average
A	6.0	8.0	7.0
B	4.3	5.5	4.9
C	6.0	7.0	6.3
X	6.4	8.5	7.4
Y	2.0	15.0	7.1

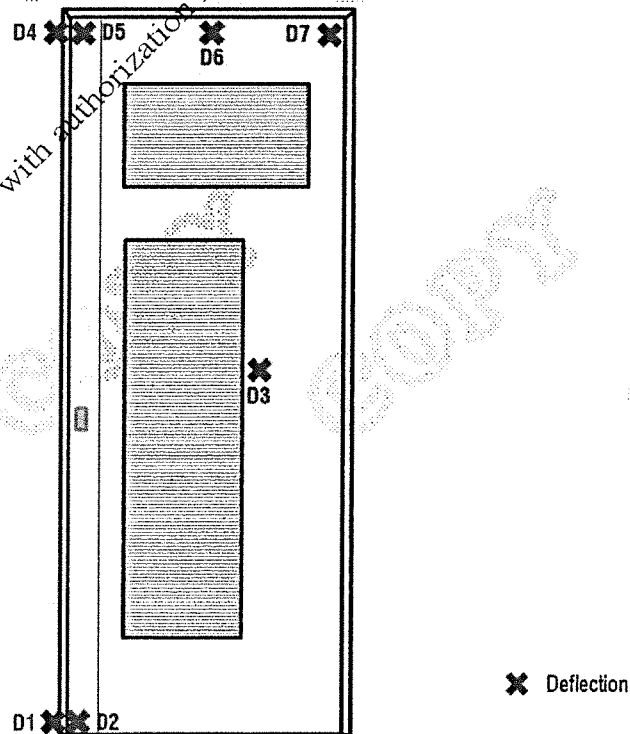
Measurements of the deflection of the test specimen were taken with a steel rule from cross line laser across the top, mid-height and bottom of the specimen. The positions of deflection measurement points were shown in *Figure 4*.

Figure 4. Positions of deflection measurement points (D) on Door A.

Position \ Time (min)	0	10	20	30	40	50	55	60	65	70
D1	+0	+1	+2	+3	+3	+3	+3	+3	+3	+3
D2	+0	+0	+1	+0	+0	+0	+1	+1	+1	+1
D3	+0	+10	+13	+14	+15	+10	+12	+10	+10	+10
D4	+0	+0	+5	+5	+8	+5	+10	+13	+17	+18
D5	+0	+0	+4	+11	+14	+6	+16	+16	+21	+19
D6	+0	+3	+10	+20	+20	+22	+25	+28	+30	+32
D7	+0	+7	+10	+18	+23	+25	+30	+30	+30	+35

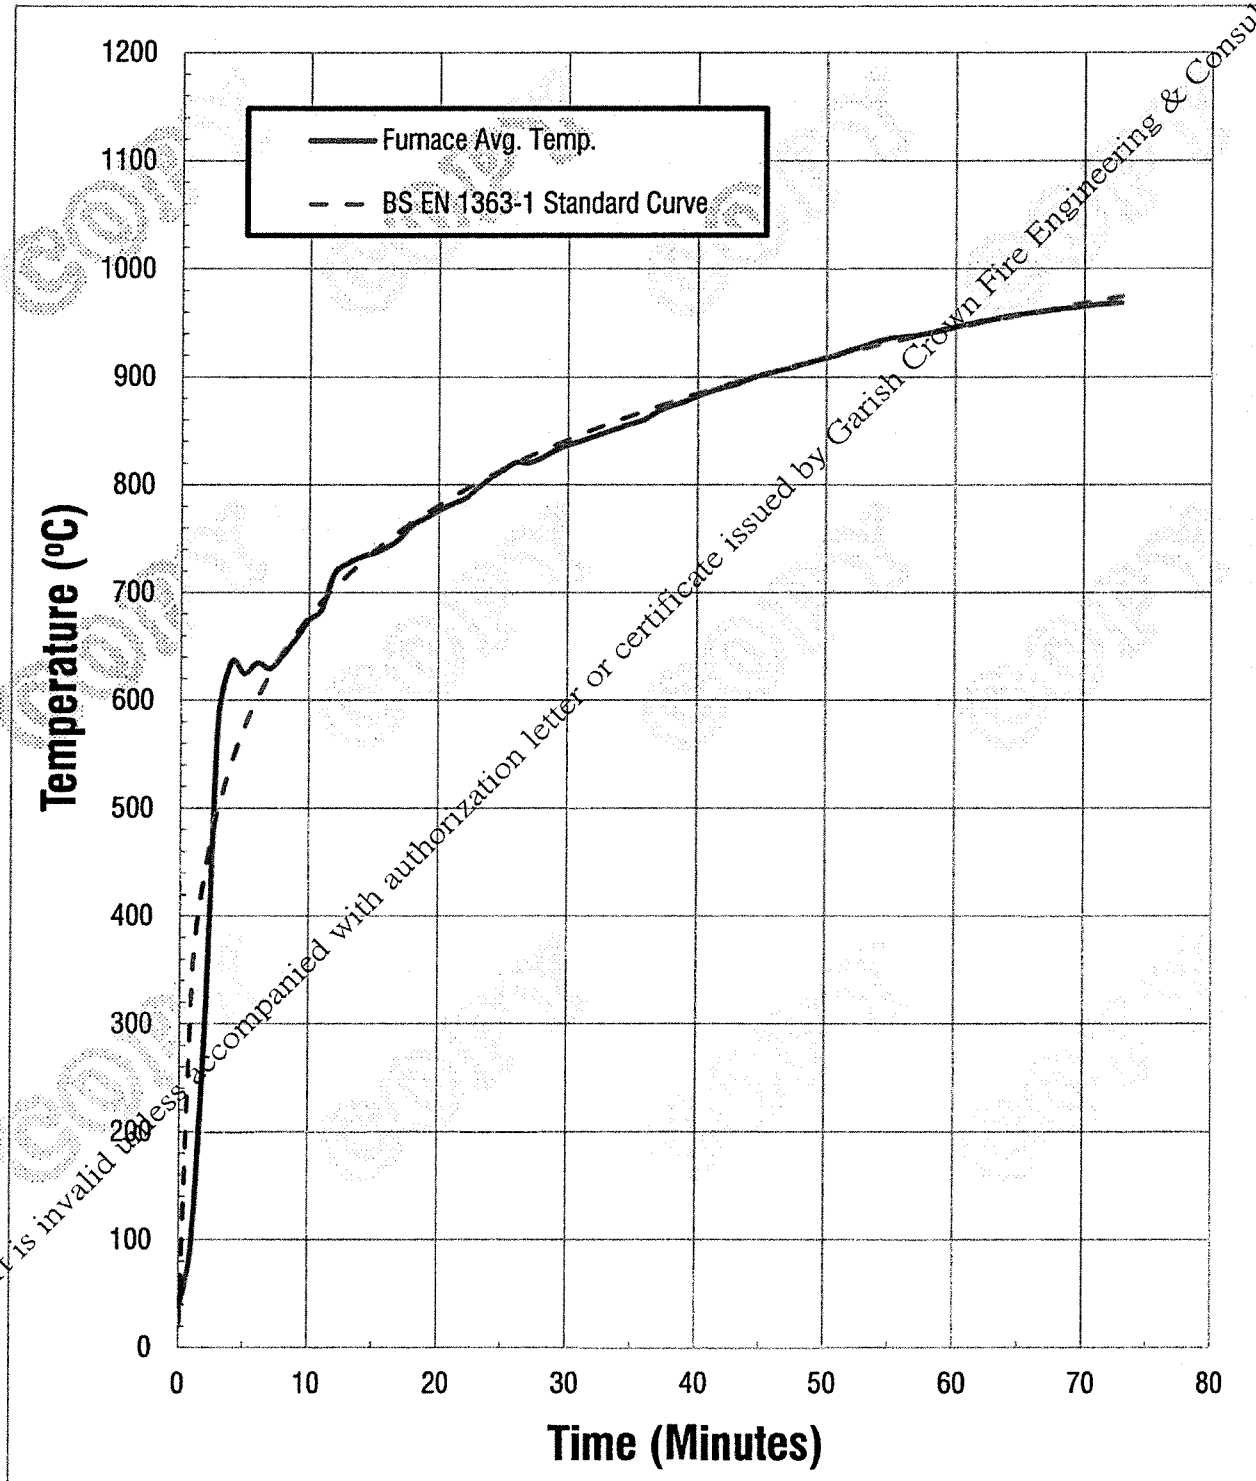
The furnace average temperature over the test period was shown in *Figure 5*.

Figure 5. Furnace average temperature over the test period.

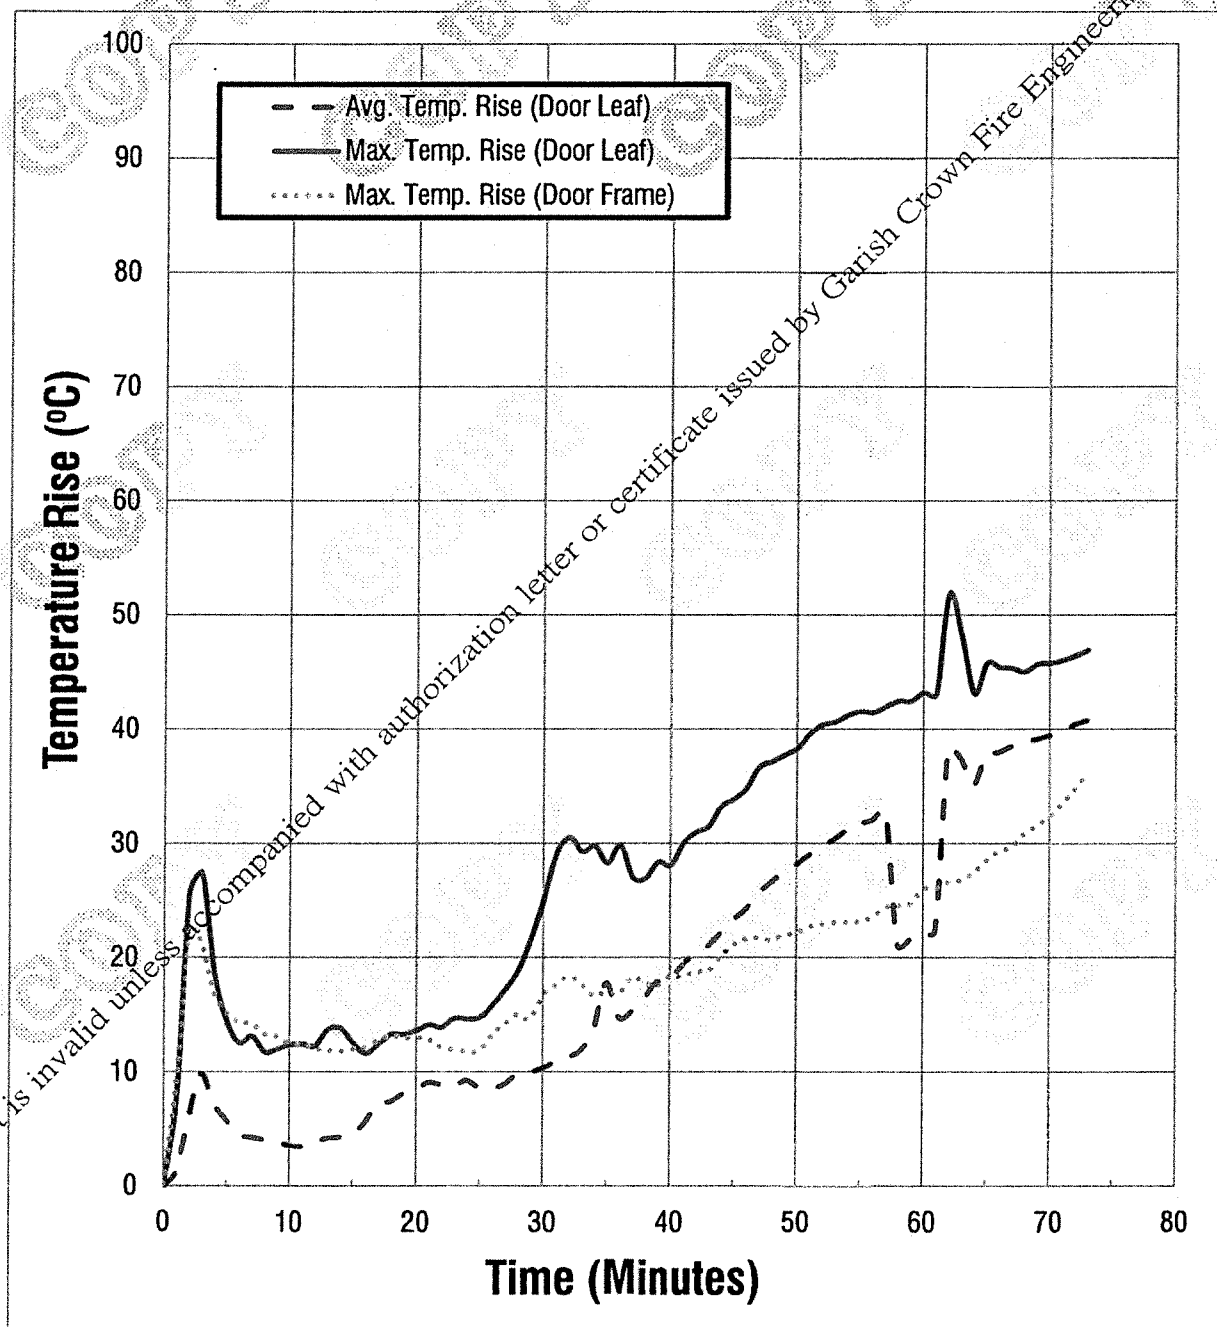
The temperature rises of unexposed surface on door leaf and door frame of Door A measured by fixed surface thermocouples over the test period were shown in Figure 6.

Figure 6. Average and maximum temperature rise on door leaf and door frame of Door A over the test period.

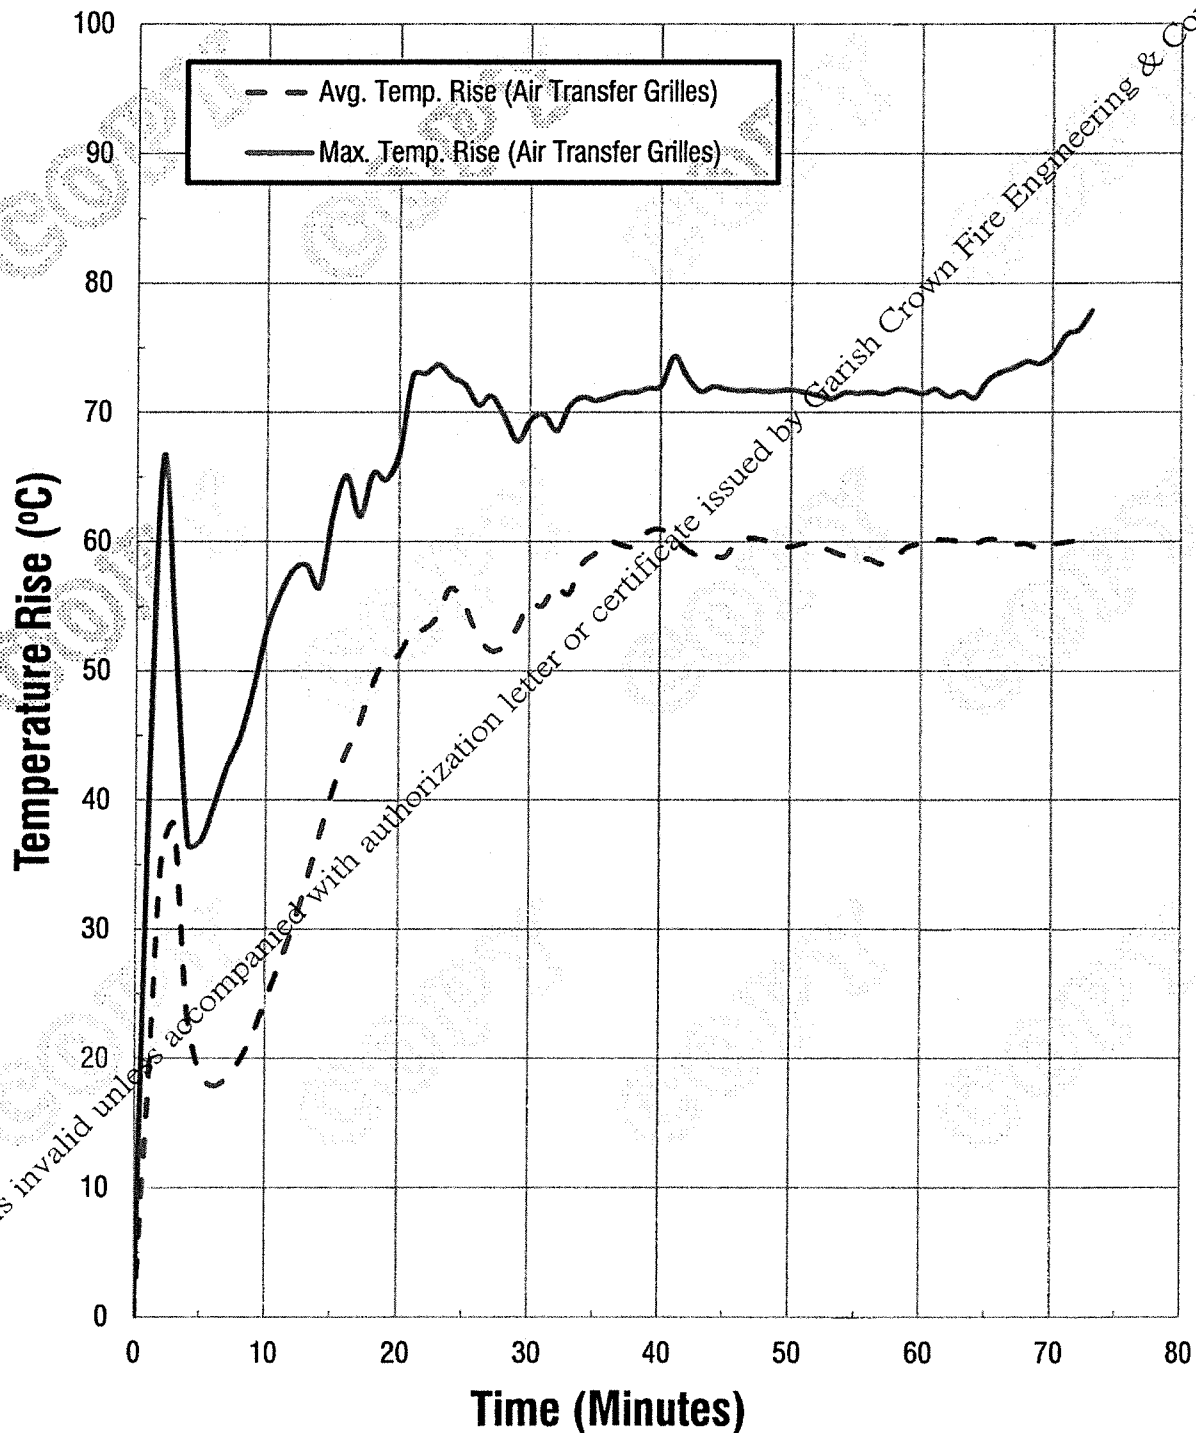
The temperature rises of unexposed surface of air transfer grilles of Door A measured by fixed surface thermocouples over the test period were shown in Figure 7.

Figure 7. Average and maximum temperature rise on Air Transfer Grilles of Door A over the test period.

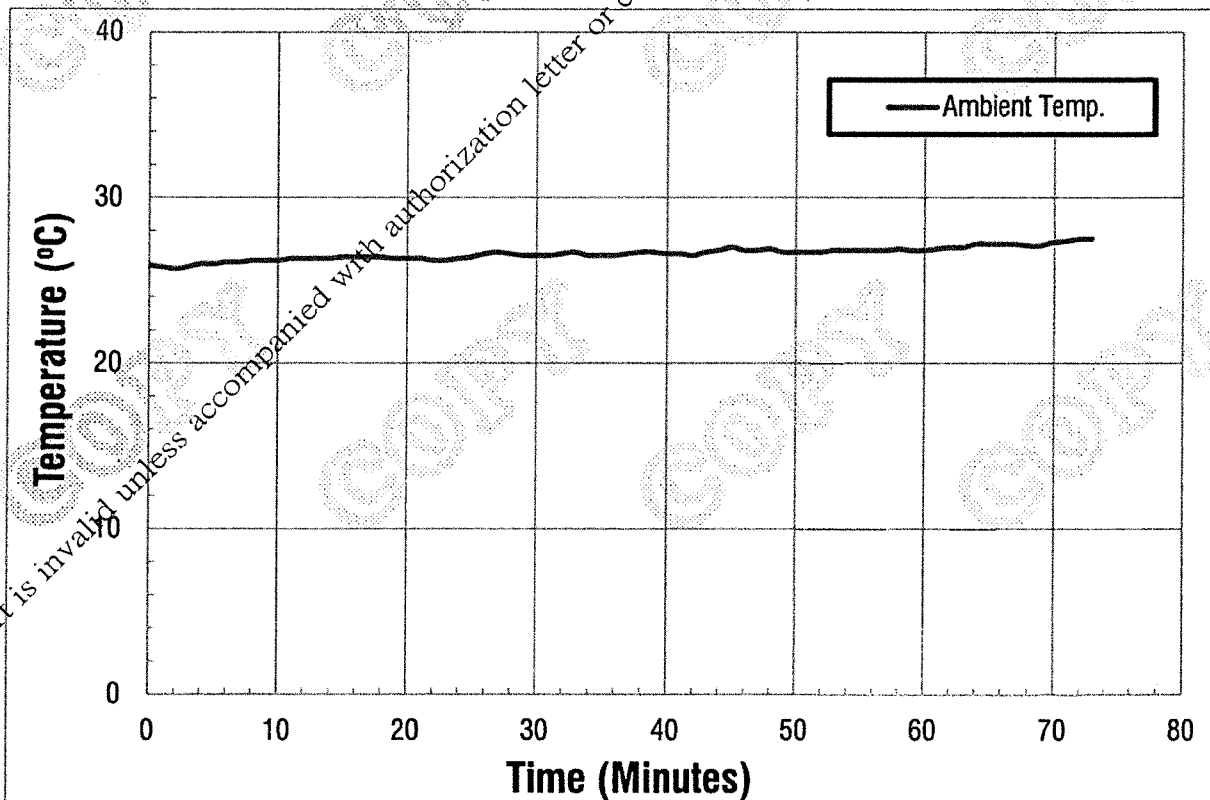
The ambient temperature over the test period was recorded and shown in Figure 8.

The ambient temperature at the commencement of test was 25.9 °C.

Figure 8. Ambient temperature over the test period.

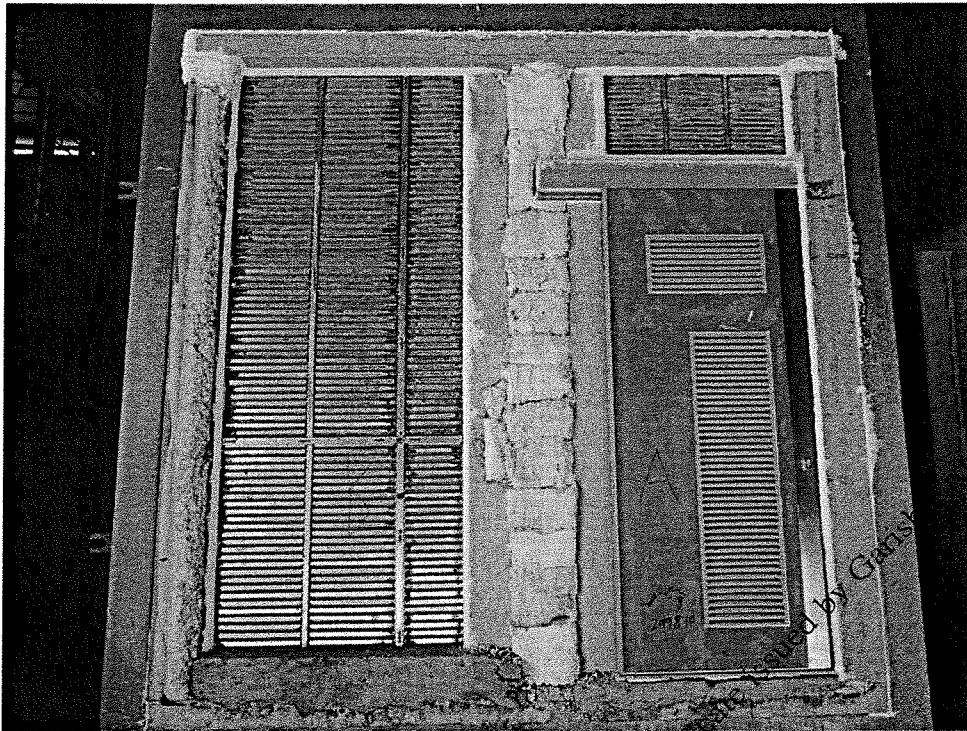
Photo 1. Exposed surface of the specimens before test. (Left: Louver B; Right: Door A and Louver C)

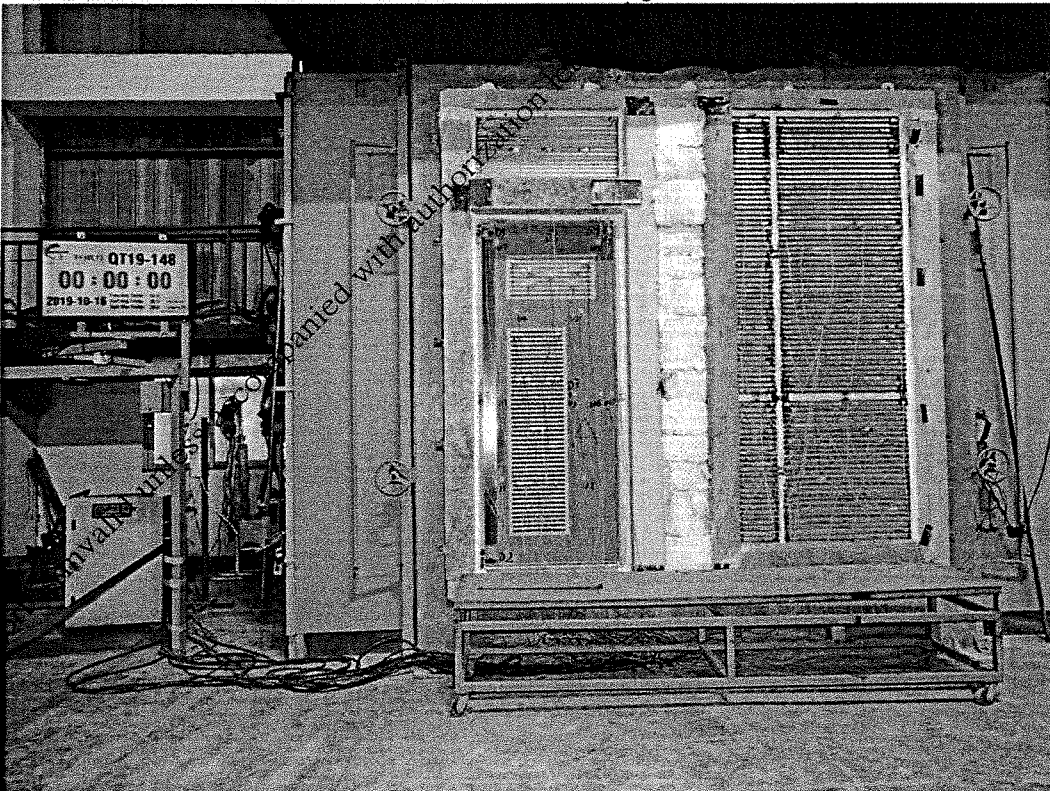
Photo 2. Unexposed surface of the specimens before test. (Left: Door A and Louver C; Right: Door B)

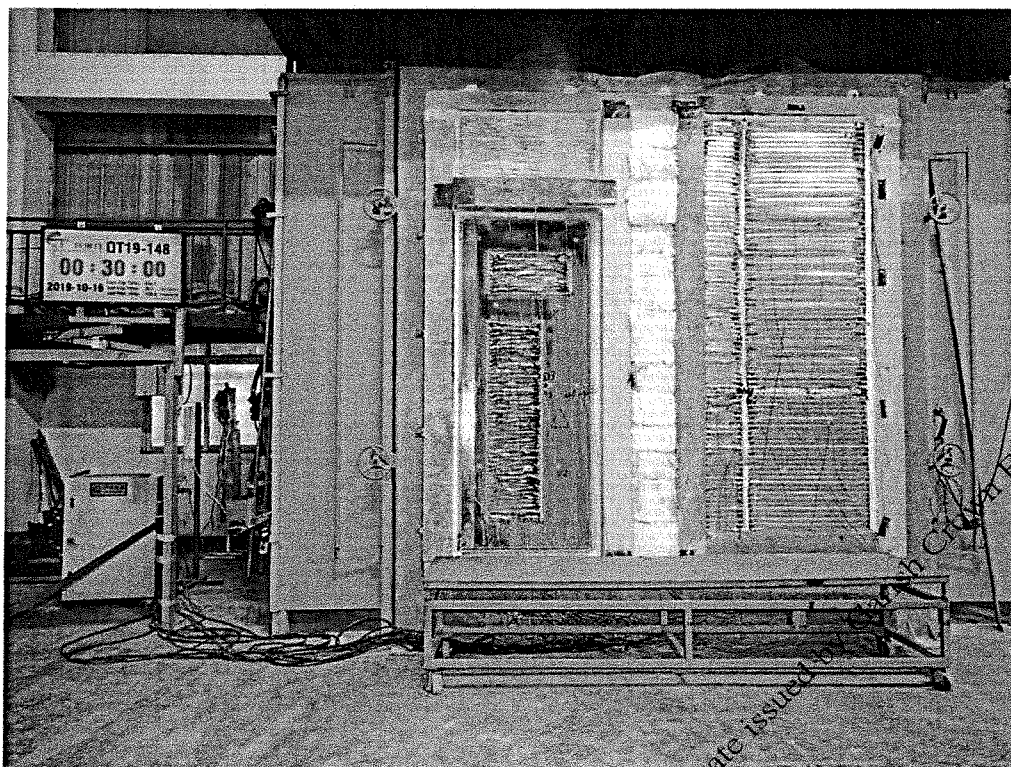
Photo 3. Unexposed surface of the specimens at 30 minutes of test.

30.00	No integrity failure had occurred.
32.36	No water mark observed from the door leaf facing. Smoke released from the door lock.
48.07	Sustain flaming over 10 seconds was observed at the top right corner of the door leaf. Integrity failure had occurred.

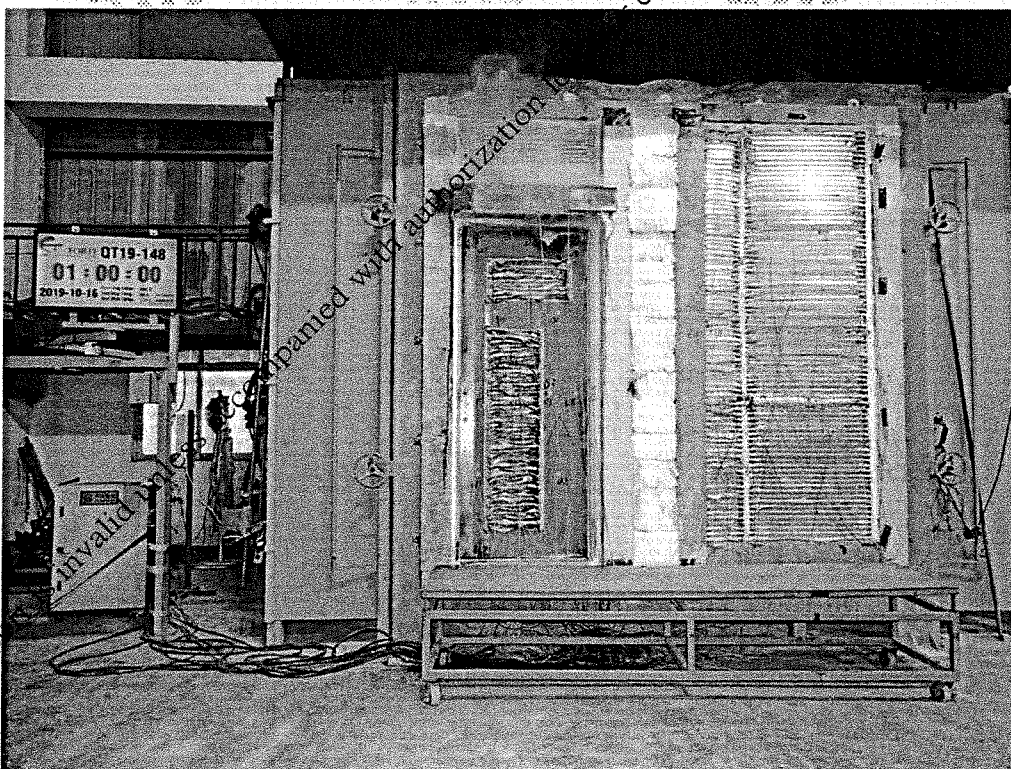
Photo 4. Unexposed surface of the specimens at 60 minutes of test.

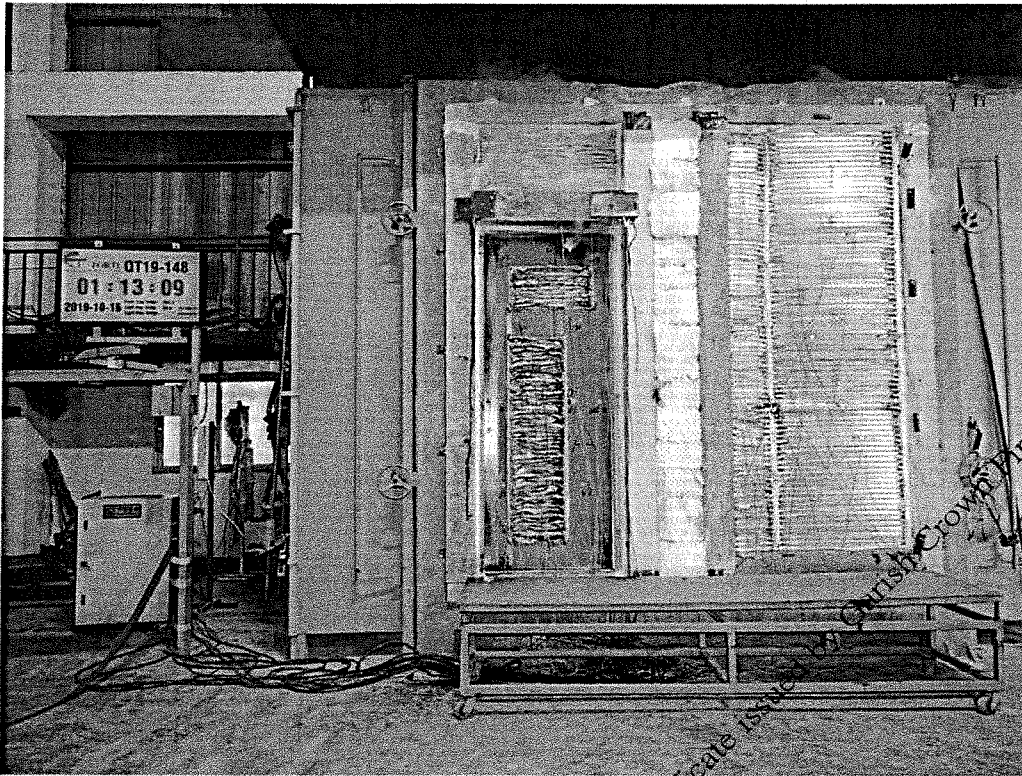
Photo 5. Unexposed surface of the specimens at the end of test.

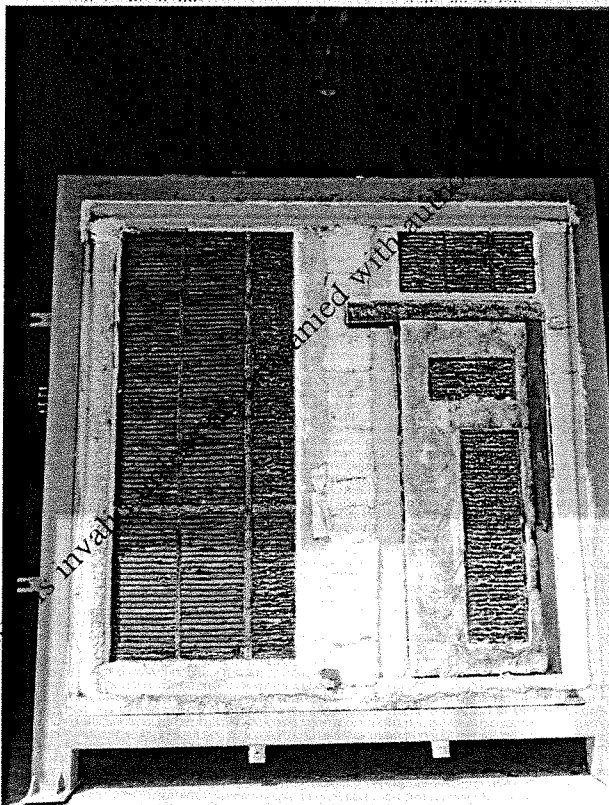
Photo 6. Exposed surface of the specimens at after test.
