# FIRE RESISTANCE TEST REPORT

**DOUBLE-LEAF COMPOSITE TIMBER DOOR with METAL CLADDING, A GLAZED ELEMENT AND A GLAZED SIDE PANEL**

in accordance with **BS EN 1634-1: 2008**

Report Number: IT16-132

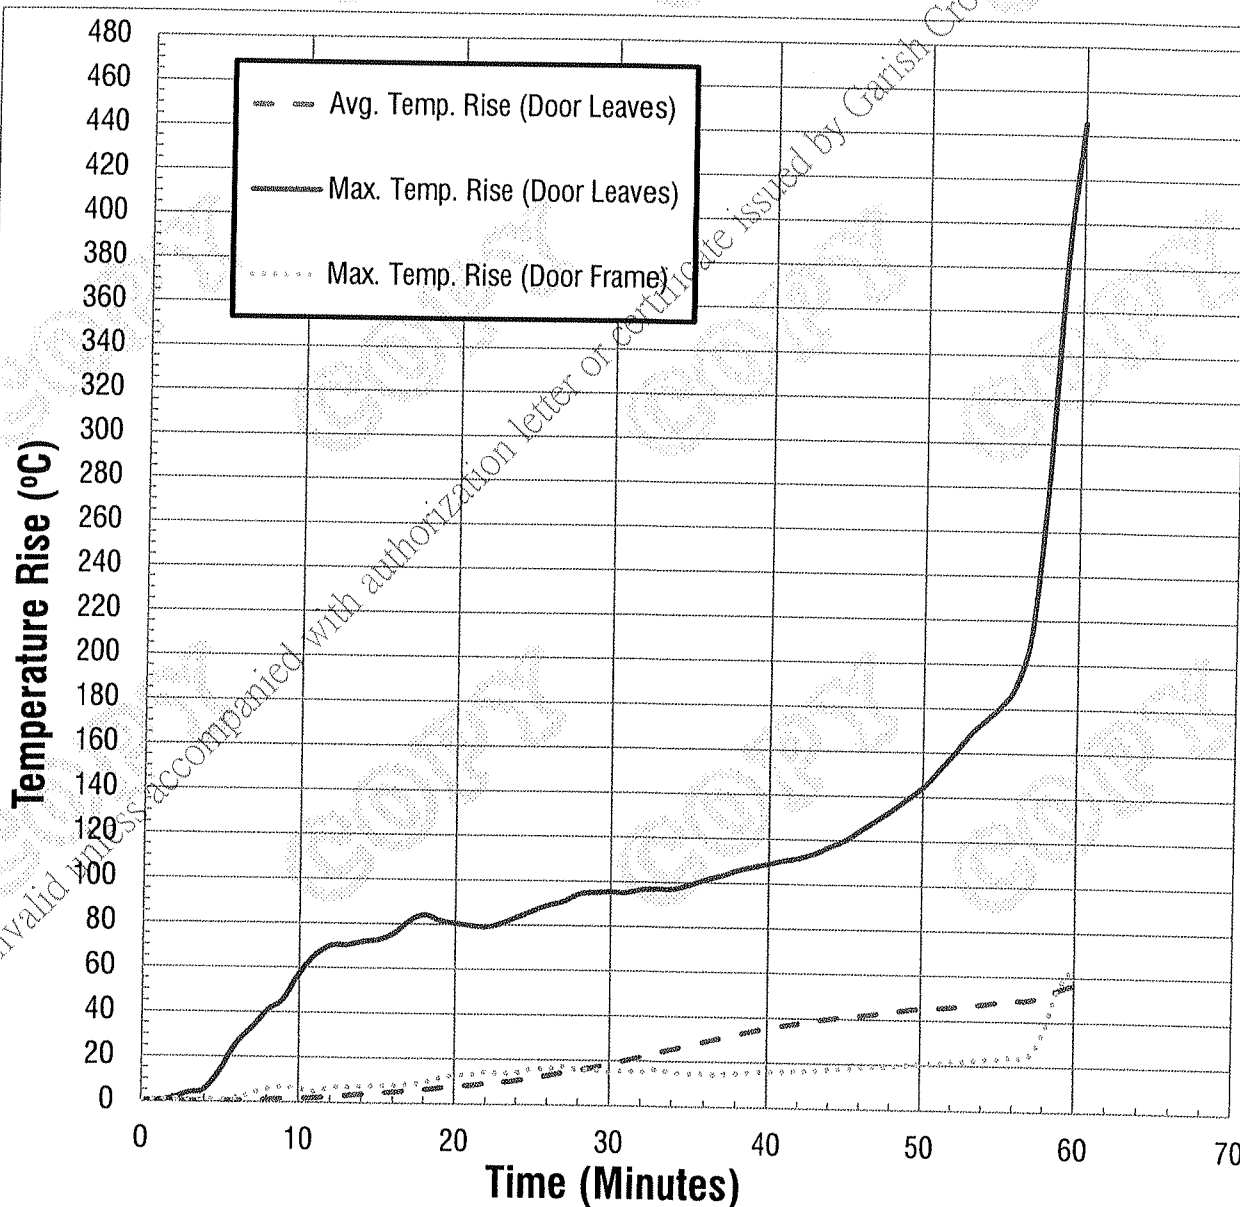
**Figure 6.** Average and maximum temperature rise on door leaf and door frame over the test period.

The temperature rises of unexposed surface on door leaves and door frame measured by fixed surface thermocouples over the test period were shown in *Figure 6*.

A fire board was covered onto the top of meeting edges at 60 minute during the test at request of the Sponsor. Due to safety reason, water was spray onto the door leaves, therefore the data captured from the thermocouples on door leaves after 60 minute was discarded.

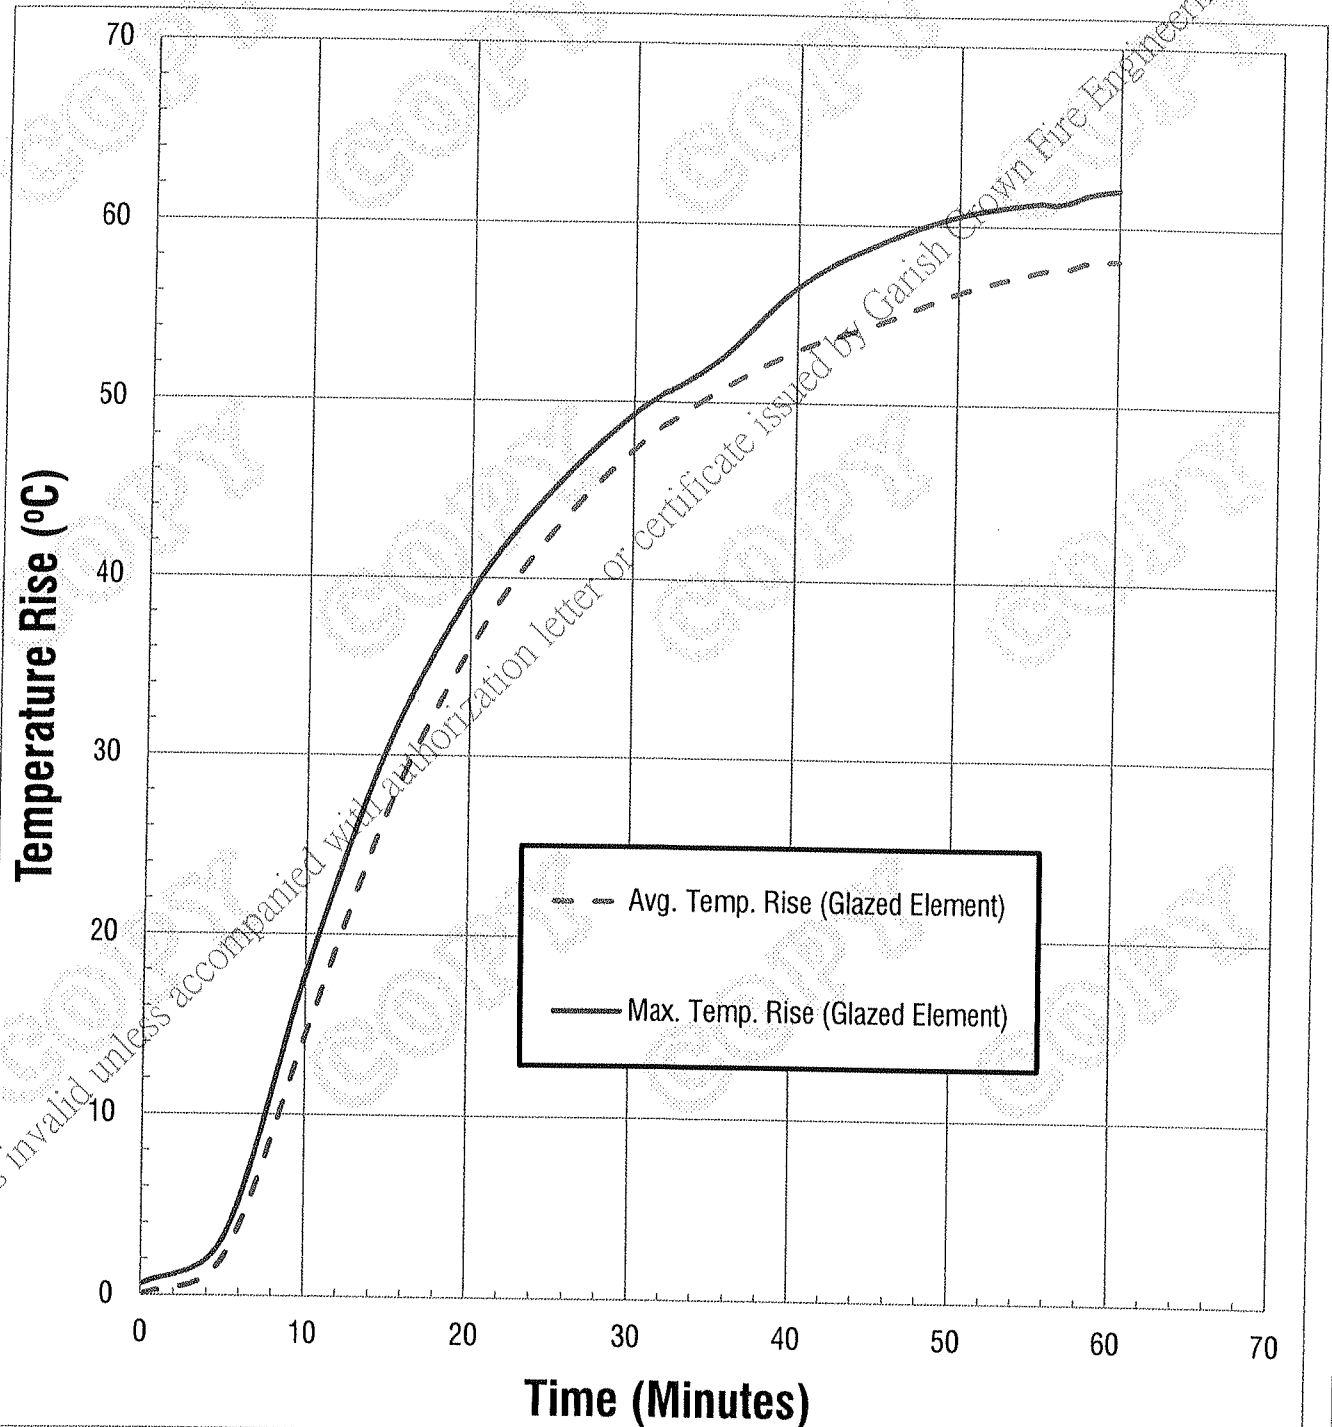
**Figure 7.** Average and maximum temperature rise on the glazed element of the specimen over the test period.

The temperature rises of unexposed surface of glazed element of the specimen measured by fixed surface thermocouples over the test period were shown in Figure 7.

Due to safety reason, water was spray onto the door leaves, therefore the data captured from the thermocouples on door leaves after 60 minute was discarded.

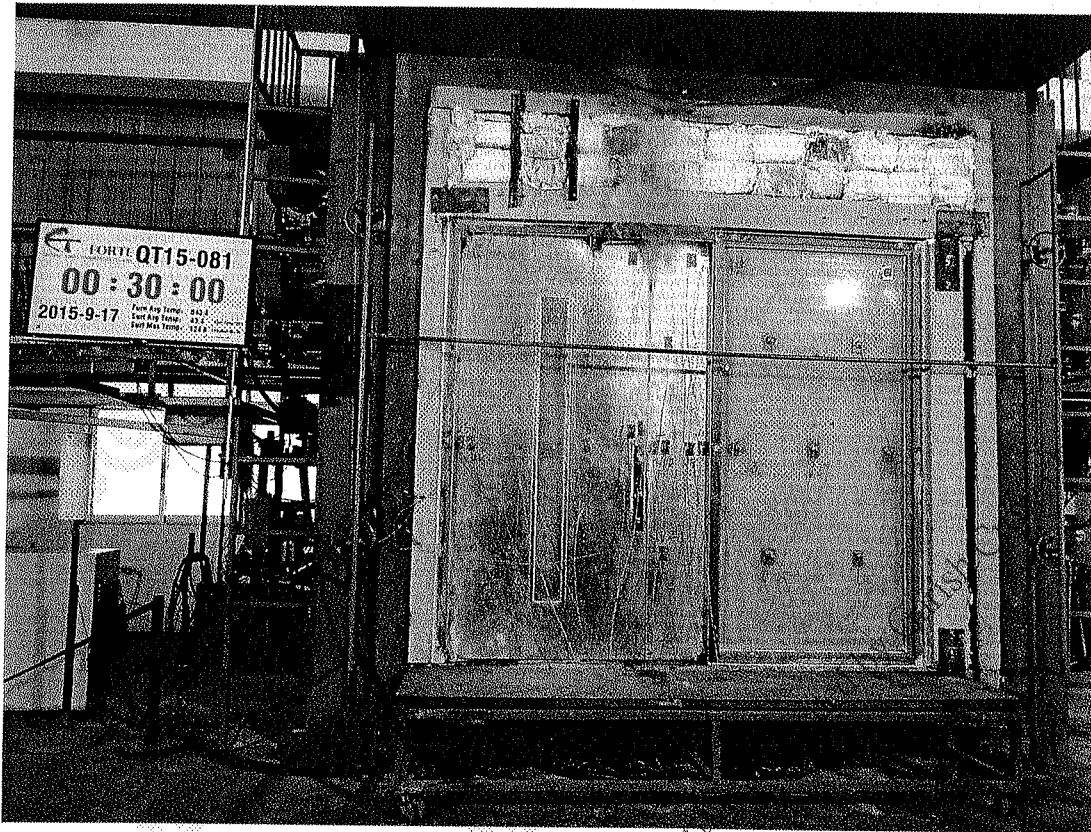
**Photo 3.** Unexposed surface of the specimen at 30 minute of test.

28.08	Cotton fibre pad test was carried out at the top of meeting edges. No flaming or glowing on the cotton pad was observed.
30.00	<b>No integrity failure had occurred.</b>
